Regal® Flushometer

NOTE: Also for use with Regal® XL
(Since mid-2010)

PARTS LIST

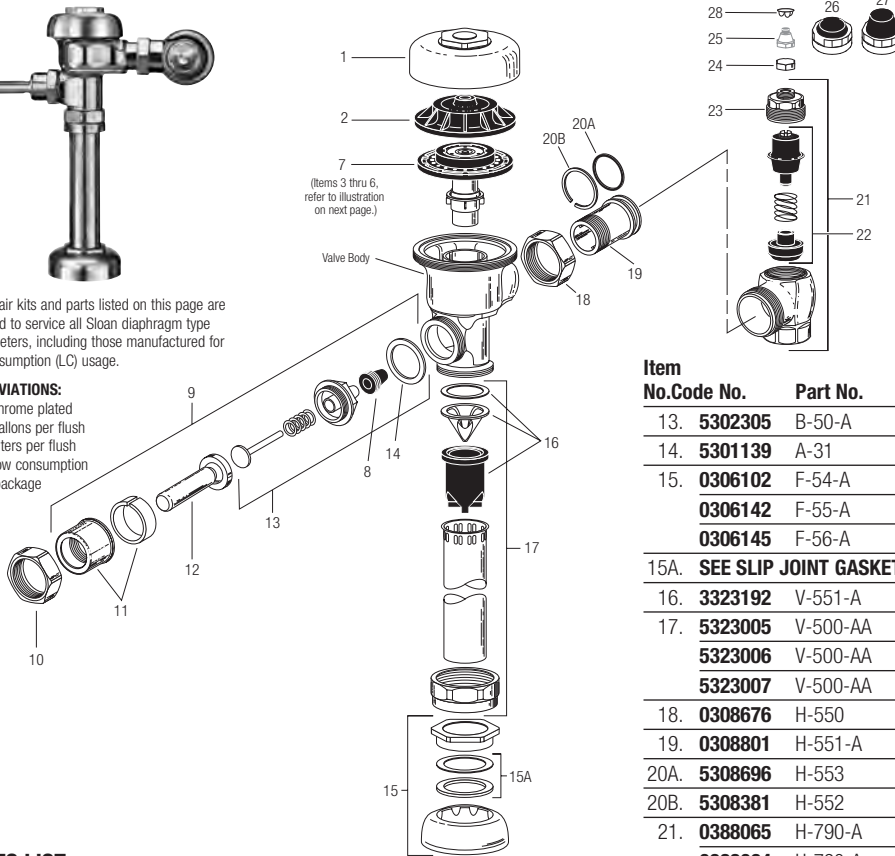
The repair kits and parts listed on this page are designed to service all Sloan diaphragm type flushometers, including those manufactured for low consumption (LC) usage.

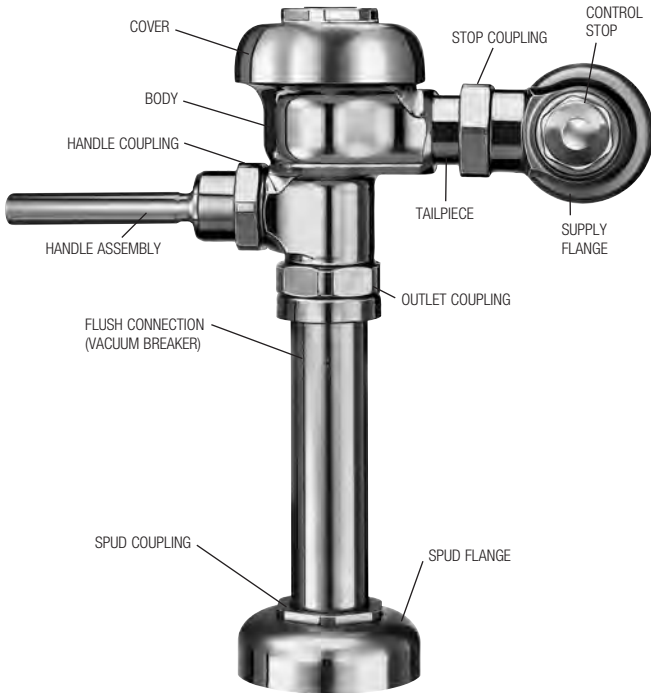
MASTER FLUSHOMETER REBUILDING KITS (SEE PARTS LIST – ON PREVIOUS PAGE)

Refer to Parts List. Includes Items 7, 13, 16 & 20

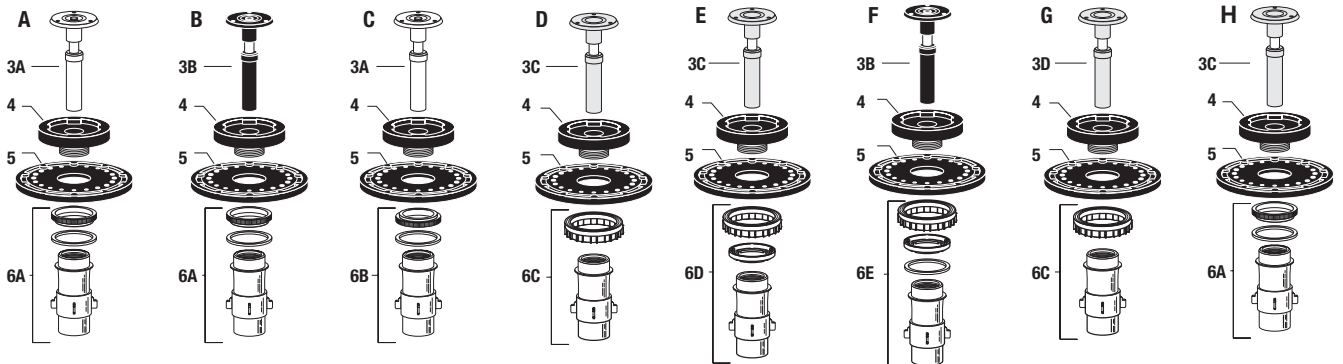
ITEM 7. INSIDE PARTS KITS (SEE ILLUSTRATIONS BELOW)

Item No.	Code No.	Part No.	Application
A.	3301036	A-36-A	4.5 gpf/17.0 Lpf - Closet
B.	3301037	A-37-A	1.5 gpf/5.7 Lpf - Urinal
C.	3301038	A-38-A	3.5 gpf/13.2 Lpf - Closet
D.	3301041	A-41-A	1.6 gpf/6.0 Lpf - Closet
E.	3301044	A-42-A	1.0 gpf/3.8 Lpf - Urinal
F.	3301081	A-43-A	0.5 gpf/1.9 Lpf - Urinal
G.	3301024	A-44-A	2.4 gpf/9.0 Lpf - Closet

H. 3301045 A-140-A 1.28 gpf/4.8 Lpf - Closet
